River Resource Center of Musconetcong Watershed Association

Location of Project: Asbury, NJ
Owner: Musconetcong Watershed Association
Submitted by: Mike Cronomiz

Overview

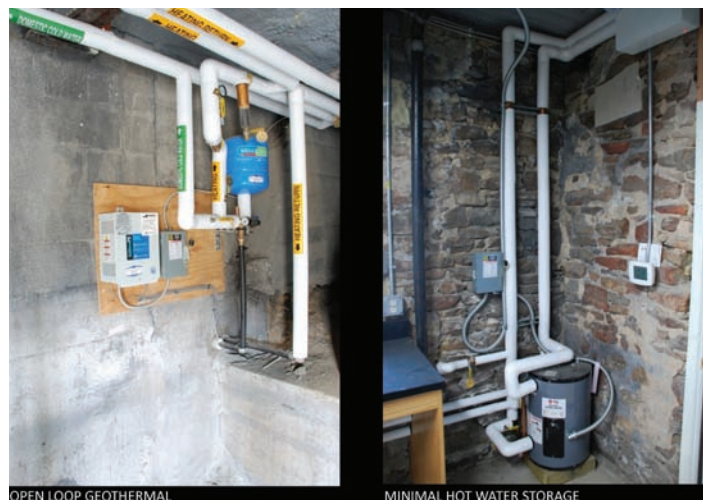
OPEN LOOP GEOTHERMAL

MINIMAL HOT WATER STORAGE

is extracted (winter) or exchanged in cooling. A geothermal heat pump is used for heating and cooling. One well water source provides water for both domestic consumption and HVAC. The masonry structure acts as a ‘heat sink’ to minimize temperature fluctuations. The building employs a high degree of thermal insulation in the form of urethane foam on the basement ceiling and on the metal roof. Exterior sheet insulation is covered with stucco. Heating and cooling requirements are minimized. With a high percentage of natural light flooding the work areas and efficient halogen and LED lighting systems, the building achieves a 48% energy use reduction over buildings of comparable size and use.
